CASE STUDY

REMOVAL OF IRON CARBONATE DEPOSITS FROM HEAT EXCHANGERS USED IN AMMONIA PRODUCTION USING TECH SONIC CLEANING

Tech Sonic LP, Morinville, Alberta, Canada

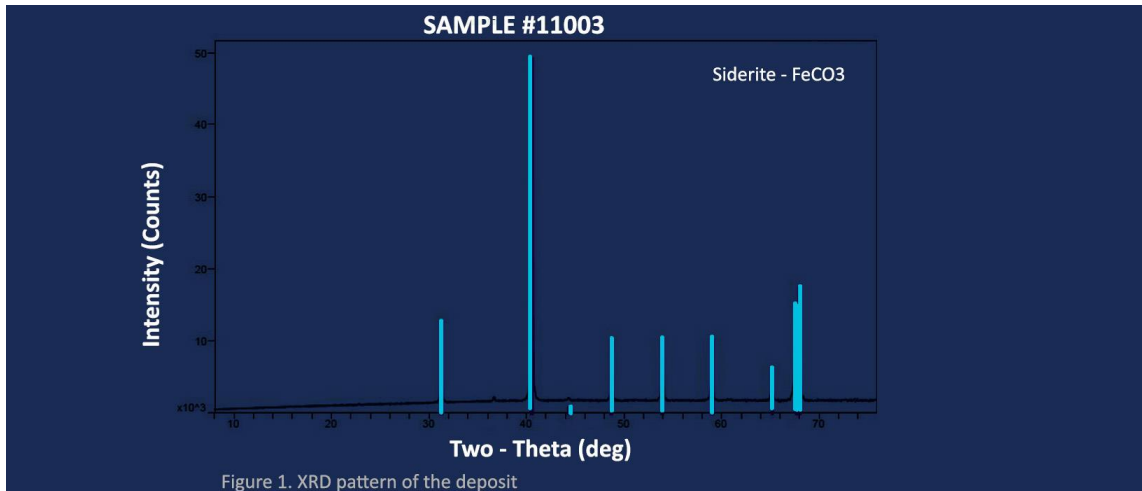
Using EDS, XRD and chemical analysis of the tube side fouling, the main constituents are noted in **Table 1 and Figure 1**.

TABLE 1. DEPOSIT COMPOSITION

COMPONENT	Wt%
FeCO ₃	96
CaMg(CO ₃) ₂	3
Alumino Silicates	<1

The main fouling component FeCO_3 (siderite) had presented a challenge to maintenance over the past 25 years. Turn-around crews employed everything from the latest high-pressure water cleaning rotating tips at 40, 000 PSI, to the harshest of chemical, including hydrochloric baths to try and completely remove the siderite from the tubes.

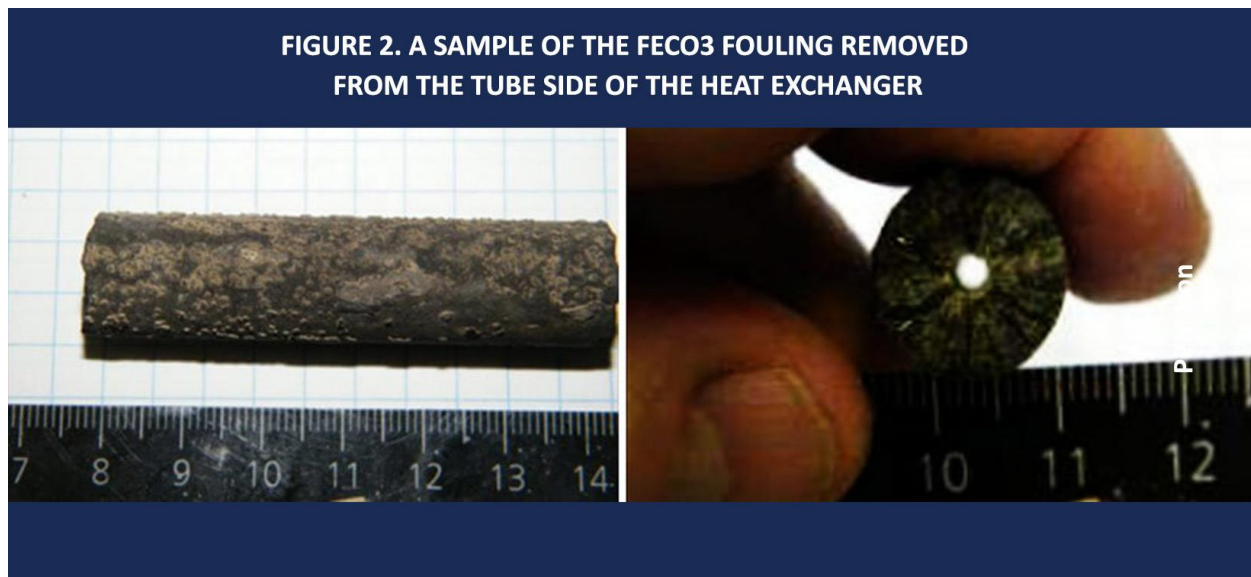
Figure 2 shows an example of the severe fouling observed on the tube-side of the exchangers.

The tube side fouling is not visible in the photos, however each tube was severely fouled with material similar to that shown in Figure 2.

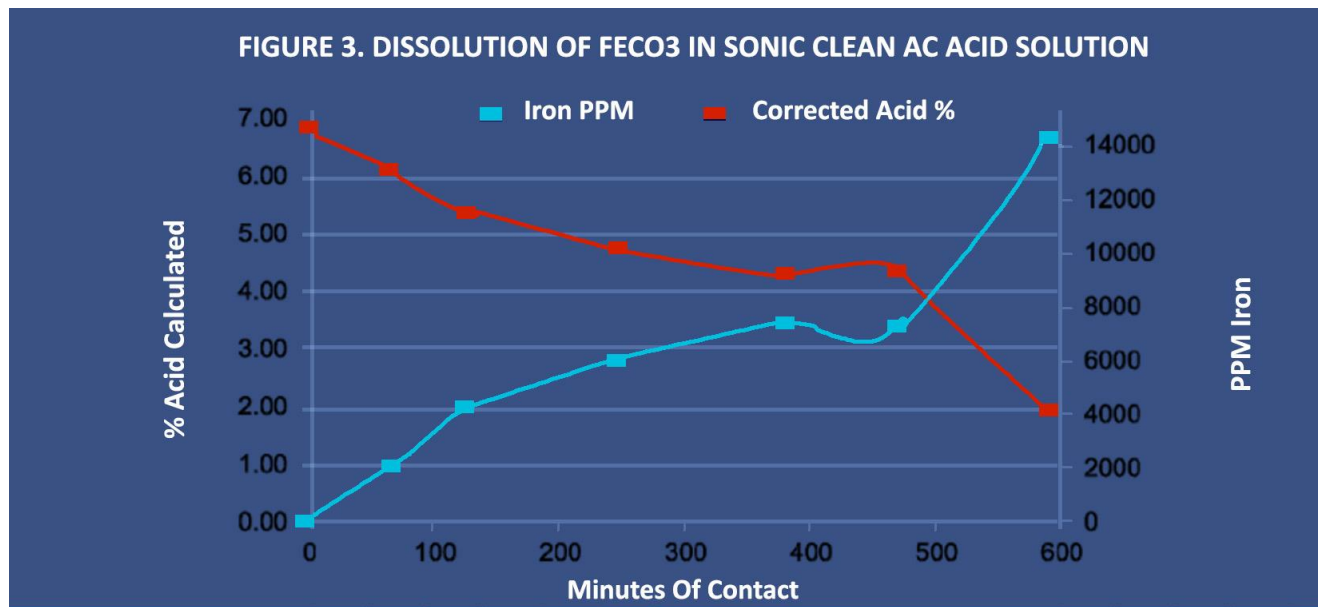
Figure 3. shows little or no reaction initially as the solution is heating up, but a rapid dissolution of the solids is seen once a range from 40 and 60°C is reached, after a contact time of 500 minutes. Heat is generated as a by-product of the ultrasonic cavitation in the fluid and the reaction rate increases drastically as the solution temperature nears 60°C at which temperature the cavitation conditions are optimized.

The cavitation produced by the ultrasonic waves provides both mechanical action at the dissolving surface as well as a kinetic advantage by accelerating the reaction by the disruption of the diffusion layer.

This acceleration of the reaction rate offered by the ultrasonic process is a key component toward reducing the overall cleaning time for these heat exchangers.

To determine the reaction rates in the organic acid concentrate, a large deposition sample was placed in 100ml of 8% acid. A 0.5ml sample was taken at intervals of time and was then analyzed by ICP.

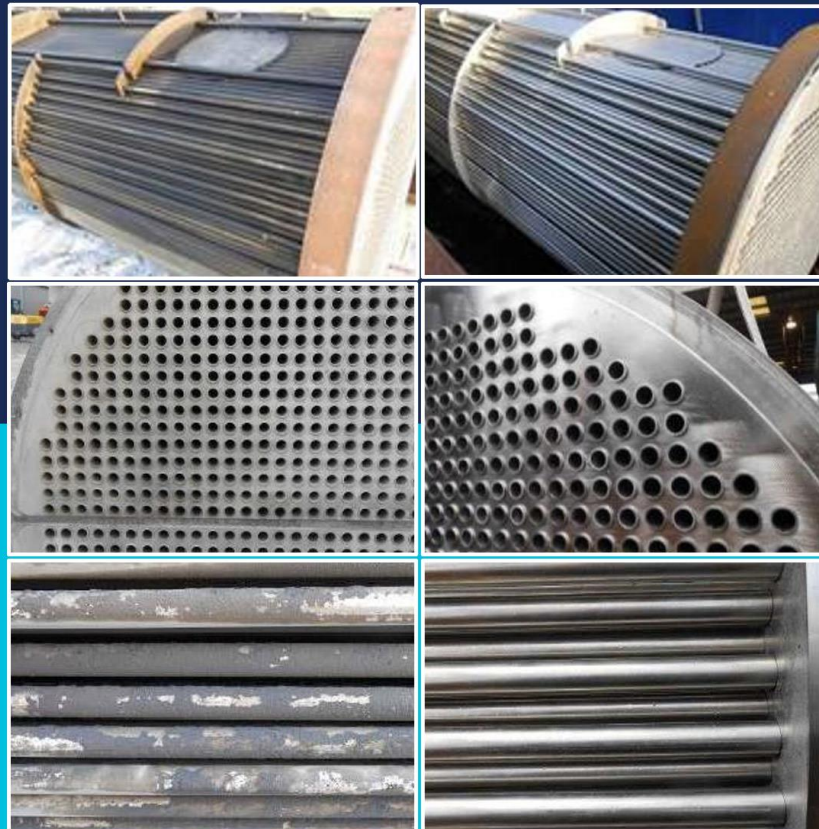
FIGURE 4. BEFORE AND AFTER PHOTOS OF ONE OF THE EXCHANGERS CLEANED

Using the ultrasonic chemical cleaning method allowed the client to have these units back into operation in 9 days, 21 days sooner than previously experienced. **Figure 4 shows some before and after pictures of one of the exchangers cleaned in this project.**

The shell side of the exchangers were not initially noted by the client to be of a particular concern, it was noted that after cleaning these bundles looked like new on the outside of the tubes as well as on the inside. Heat transfer performance data provided by the client also proved that the units were restored to 100% of design performance.
